# Biogenic sulfuric acid corrosion resistance of MasterSeal 7000 CR

**Report no. 20220927A**

**Fraunhofer Institute for Environmental, Safety,  
and Energy Technology UMSICHT**

Oberhausen, 27 September 2022

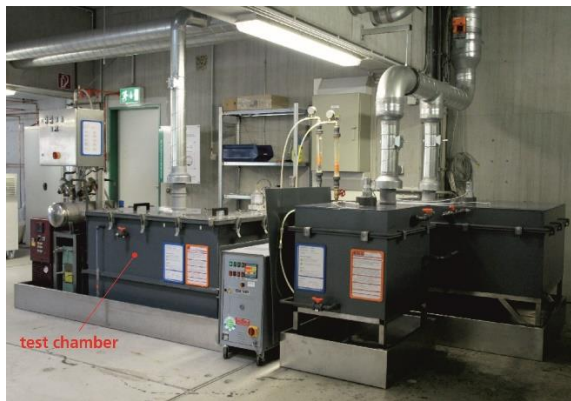
Figure 1 Test facility at Fraunhofer UMSICHT.

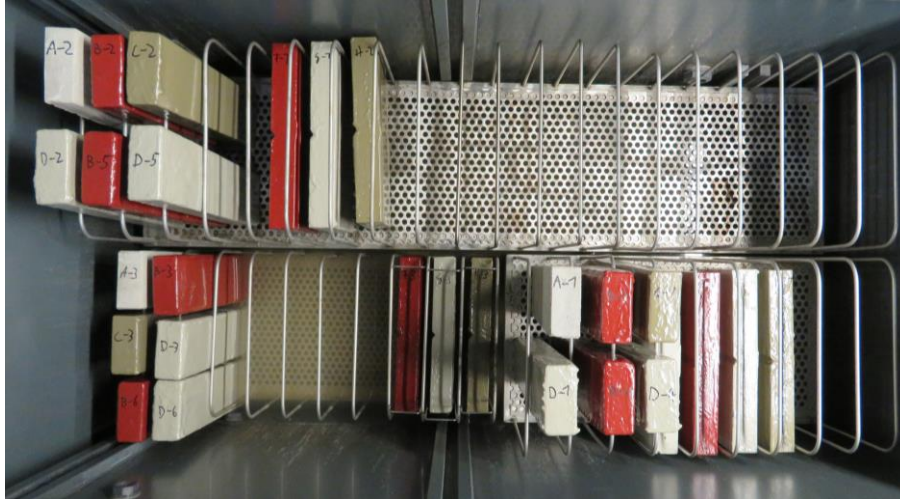
The concrete specimens were placed in the bottom of the chamber using a rack made of stainless steel. In figure 4 the placement of the concrete specimens is shown.

Placement of concrete specimens

Figure 4 Placement of concrete specimens and polymer films. Specimens of MasterSeal 7000 CR are the ones in red colour. The specimens in other colours have been provided by Master Builders Solutions Deutschland GmbH for additional testing and comparison.

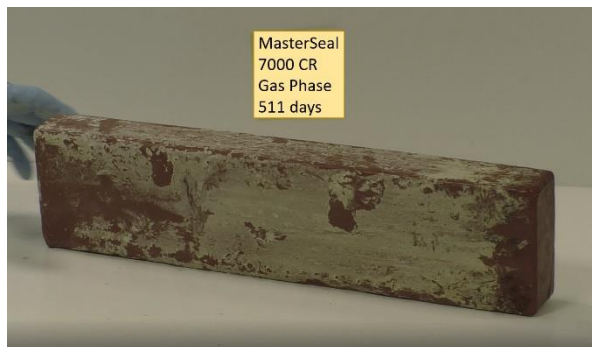
Specimen after 511 days testing.

**After visual inspection, abrasion resistance test and adhesion test on specimens stored 511 days in the weathering chamber at the Fraunhofer UMSICHT, no reduction of properties of MasterSeal 7000 CR were observed.**

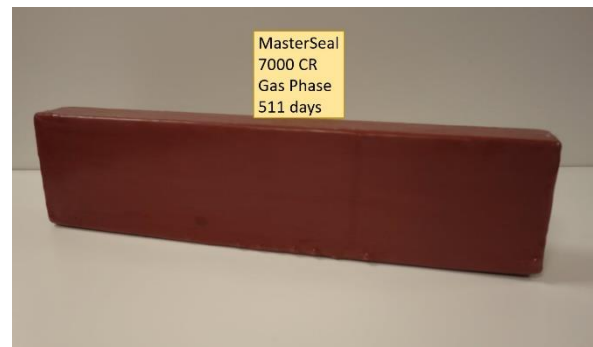
Specimen after 511 days testing and cleaning.

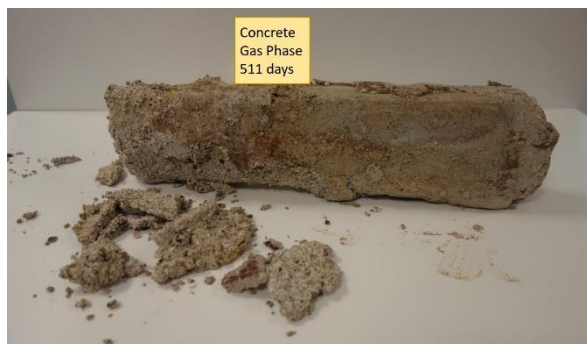
Specimen after 511 days testing.

The highest cell numbers of the remaining strongly acidophilic sulfur oxidizers were detectable on uncoated test specimens exposed in the gas space of the test, which appeared visually heavily corroded after completion of the test with comparatively low sulfur loads on the surfaces (approx.  $115 \mu g cm^{-2}$ ).

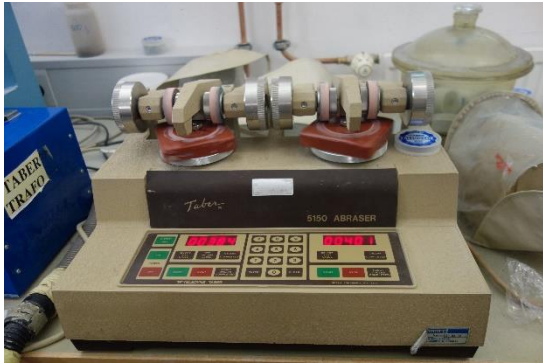
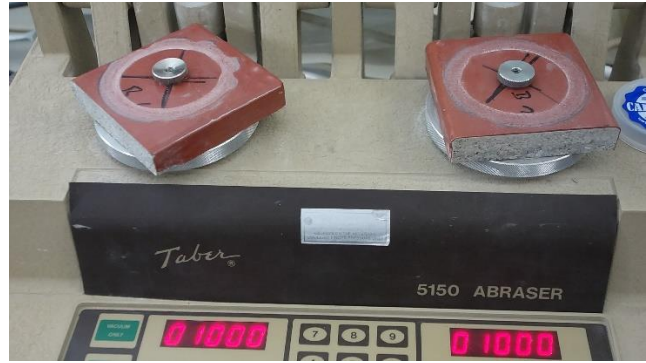
### 3. Abrasion resistance of MasterSeal 7000 CR: Taber test – after 511 days testing

Testing in accordance with EN ISO 5470-1  
Weight loss after 1000 cycles: 220 mg (Required: < 3000 mg)
