Clarifier refurbishment

Clarifier Refurbishment, Northumbria

Repair / waterproofing of concrete walls & protection of steel pipework

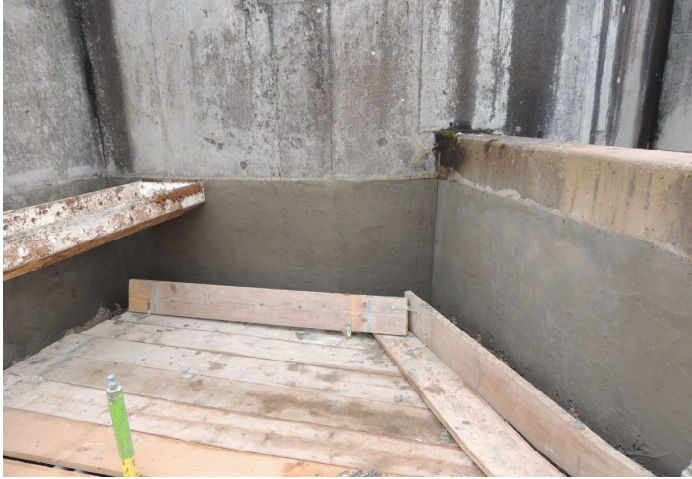
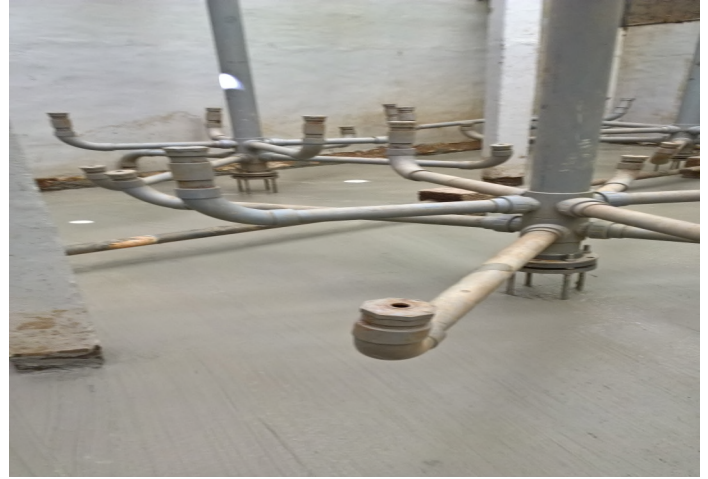
Repair / waterproofing of concrete walls & protection of steel pipework

The concrete surface was treated with high pressure water to remove all contaminants. The concrete surface was built up using MasterEmaco S 420 incorporating MasterSeal 600 polymer emulsion to build the concrete surface back to the original profile.

Joints were sealed with MasterSeal 930 bandage applied on top of the MasterSeal 933 adhesive. MasterSeal 586 was then applied in one layer of 3mm to re-profile the concrete walls.

MasterSeal M 808 was applied in 3 coats to protect the repaired concrete surface. Steel pipework and channels were grit blasted to remove all corrosion products. MasterSeal M 808 was applied in two coats by roller and brush onto the steel surfaces.
