# **Douglas Village Multi-Storey Car Park, Cork**

Refurbishment of car park after fire caused millions in damage

Our reference in Cork (Ireland): Douglas Village Multi-Storey Car Park

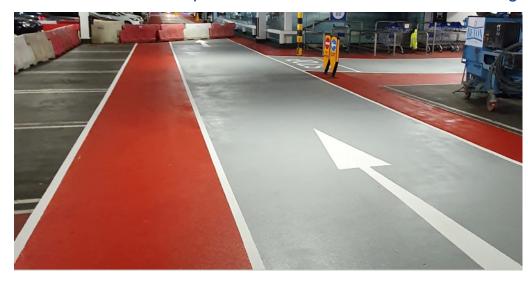
Following a major fire in the multi storey car park, an area of over 12,000m² required full refurbishment; some areas required existing deck coatings to be removed and a new system re-applied & the worse affected areas required the installation of a new concrete substrate in addition to the new deck waterproofing system

The ramps which are the most trafficked areas needed a solution that provided a very hard-wearing polyaspartic finish. MasterSeal Traffic 2262 was specified & applied, which is an exceptionally hard-wearing, crack-bridging, skid-resistant, car park deck system; featuring a build-up system of MasterTop P622 primer to completely seal the substrate. Then a body coat of MasterTop BC375N with broadcast aggregate is applied and a top-coat of MasterSeal TC 374

MasterSeal Traffic 2205 was specified & applied in the parking bays, driving aisles and walkways areas. MasterSeal Traffic 2205 is a liquid applied, crack bridging, skid resistant, car park deck waterproofing system with spray-applied membrane; featuring a build-up system of MasterTop P622 primer to completely seal the substrate. Then MasterSeal M800 elastomeric polyurethane waterproofing membrane was spray applied (through a hot spray computer-controlled machine), and a top-coat of MasterSeal TC681
