Project:
ETAP EL ATABAL

ETAP EL ATABAL – Primary sedimentation tank Repair, reinforcement, protection and waterproofing

Repair, reinforcement, protection and waterproofing

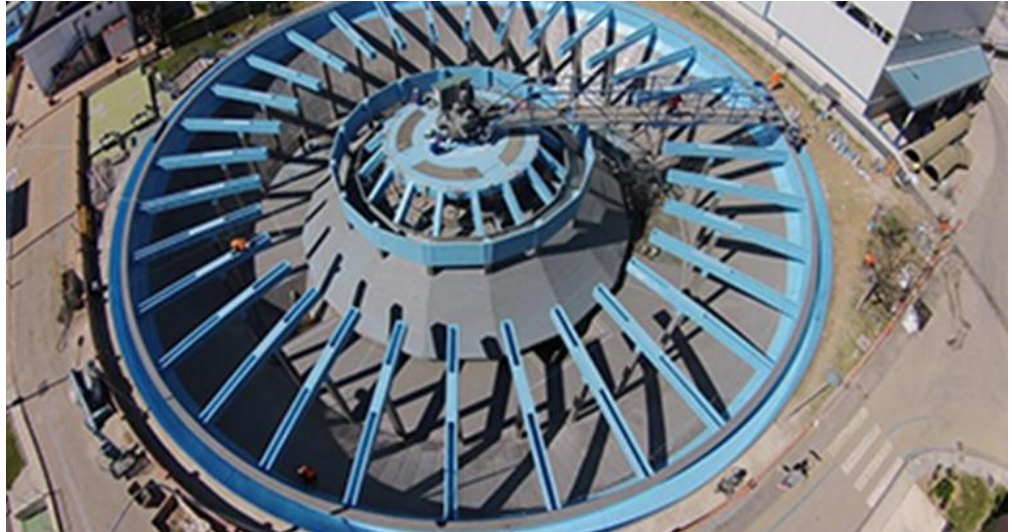
Aerial view of the primary sedimentation tank at the water treatment works ETAP El Atabal, (Málaga – Spain)

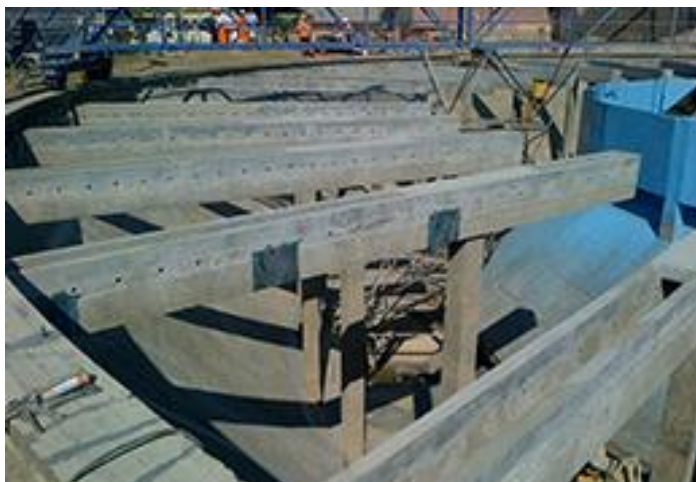
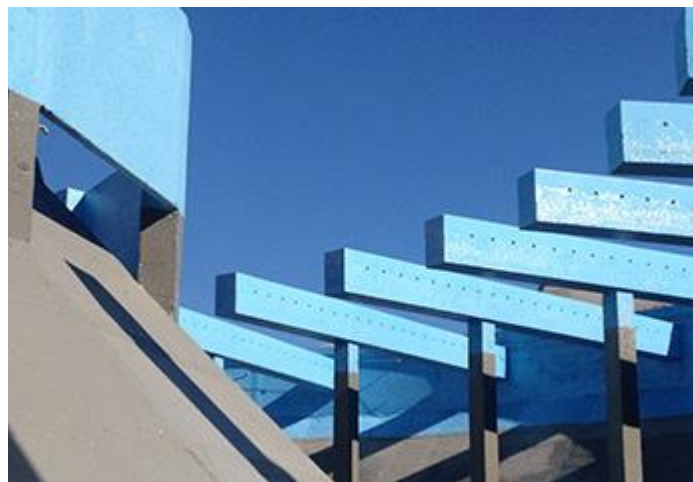
Comprehensive refurbishment of one of the primary sedimentation tanks at the El Atabal water treatment plant in the province of Málaga (Spain) was required as a result of severe damage to the reinforced concrete structures.

The damage was the result of corrosion caused by acid attack as well as chlorides and sulphates in the environment.

Full refurbishment including concrete repair, reinforcement, and protective waterproofing in accordance with EN 1504

- Structural injection of concrete using low-viscosity epoxy resin MasterInject 1360.
- Structural concrete repair using MasterEmaco S 5450 PG flowable repair mortar and MasterEmaco S 5300 thixotropic repair mortar MasterEmaco S 5300.
- Reinforcement using carbon fiber system to replace lost rebar section.
- Application of MasterProtect 8000 CI corrosion inhibitor.
- Application of MasterSeal M 808 chemical-resistant waterproofing membranes with high crack bridging properties and MasterSeal M 391.
