Fossano viaduct.  
Structural refurbishment and  
waterproofing.

## Fossano viaduct

### Waterproofing of viaduct deck with MasterSeal 6100 FX

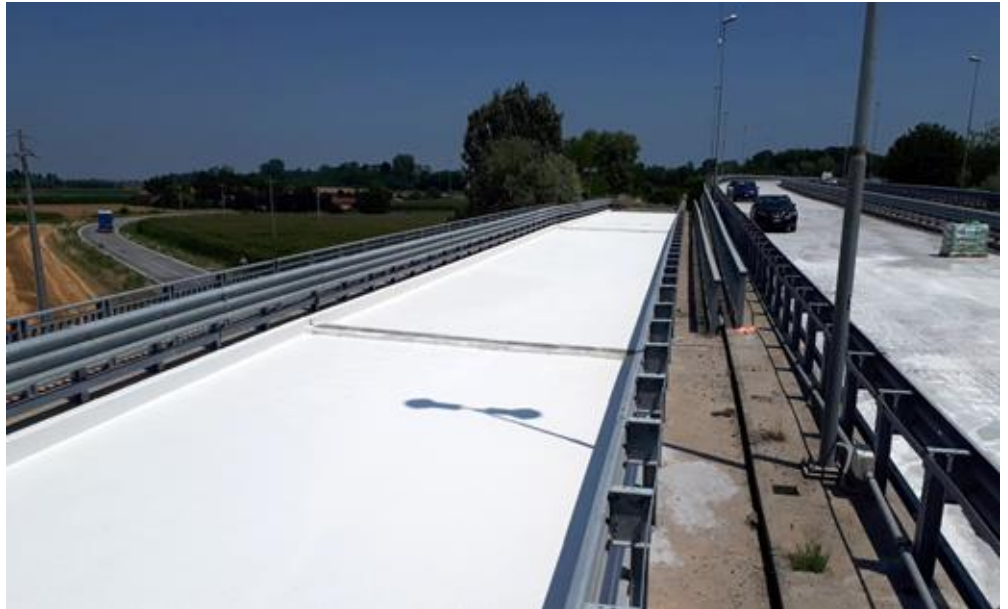
Our reference project in Fossano (Italy): Waterproofing of viaduct deck with MasterSeal 6100 FX

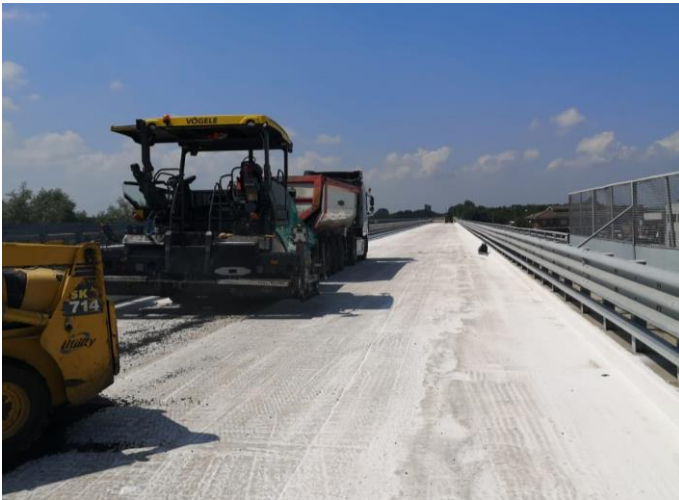
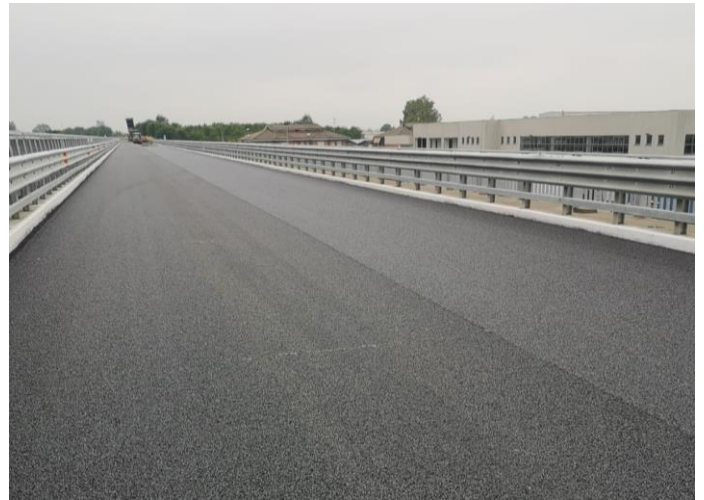
Our reference project in Fossano (Italy): Waterproofing of viaduct deck with MasterSeal 6100 FX

- Structural refurbishment with MasterEmaco S 444 FR, R4 class, concrete repair mortar reinforced with metal fibres.
- Reprofiling and levelling of the surface with MasterEmaco S 950, R3 class, polymer modified concrete repair mortar reinforced with polyacrylonitrile (PAN) fibres.
- Sealing of movement joints with MasterSeal 924 thermoplastic tape.
- Waterproofing of bridge deck with MasterSeal 6100 FX single-component elastic membrane before application of hot-rolled asphalt.

- Total area waterproofed: approx. 30.000 m<sup>2</sup>.
- MasterSeal 6100 FX applied with a thickness of 2,5 mm and approx. 2,35 kg of product per m<sup>2</sup>.
- The junction for Marene, which is close to the viaduct, was reopened to traffic in August 2019.
- The rest of the Fossano ring road was reopened in August 2020, three years after the collapse of the viaduct.
- The use of MasterSeal 6100 FX instead of traditional cementitious two-component waterproofing membranes saved approx. 30 tonnes of waterproofing material.
