Jordangate MSCP

Macclesfield, Cheshire, UK

Jordangate MSCP, Macclesfield

Concrete repairs and deck refurbishment

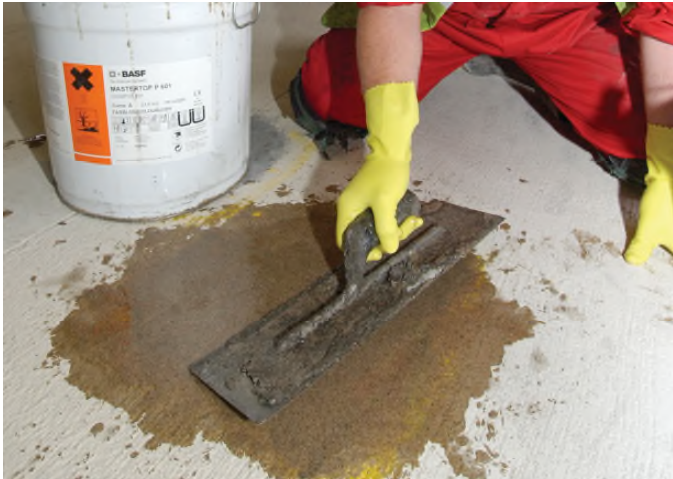
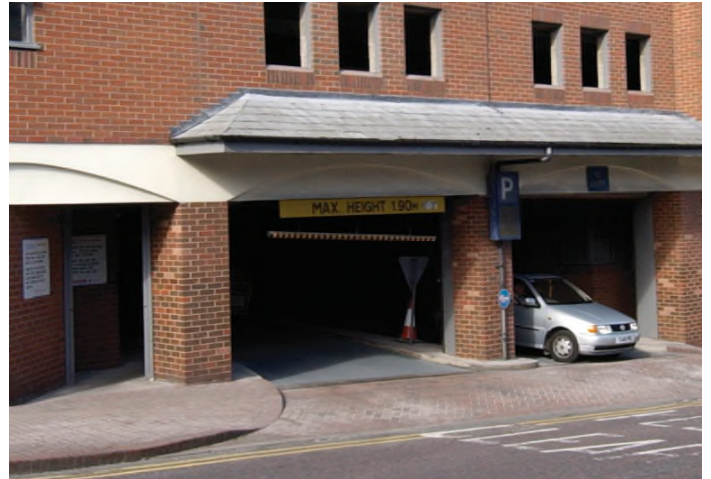
The block and beam construction of the car par required a solution that could address the cracking along the joints, so a purpose-designed strip system was developed that was then covered with a topcoat. In areas that needed to be especially durable, such as ramps and turning circles, quartz rather than sand was applied. MasterEmaco mortars were first used for patch repairs to the concrete deck.

A £570K schedule was completed with MasterSeal Traffic system from Master Builders Solutions, an approved supplier of contractor Concrete Repairs Ltd. Several Master Builders Solutions products were used to carry out the refurbishment, including a special MasterSeal Traffic strip system.
