**Project:**  
Service Reservoir

## Service Reservoir, East Sussex

### Waterproofing of joints and concrete protection

# Meades Service Reservoir No.1, Eastbourne

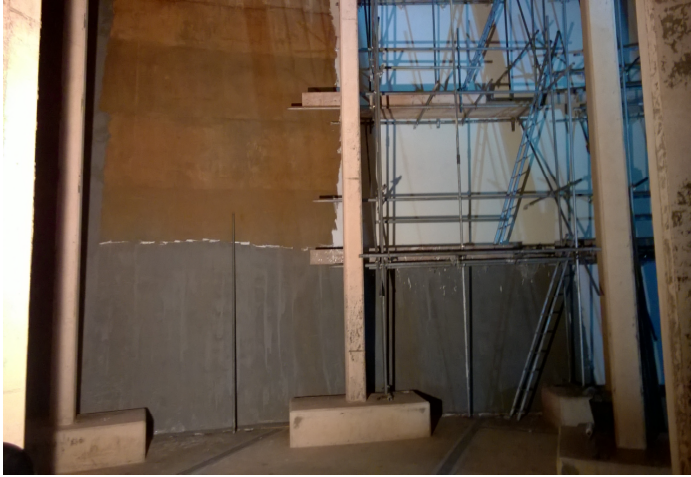
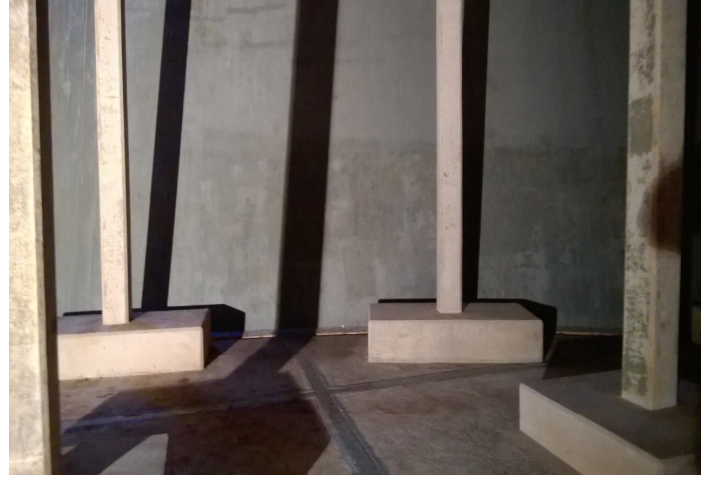
The concrete surface was treated with high pressure water to remove all contaminants. MasterSeal 930 bandage was applied onto MasterSeal 933 moisture tolerant adhesive to seal the vertical and horizontal joints. MasterSeal 588 was applied to the concrete by brush in two coats of 1mm per coat. MasterSeal 588 White was applied followed by a second coat of MasterSeal 588 Grey.
