Service Reservoir

Sevenoaks, Kent

## Service Reservoir, Kent

Protection of steel columns & waterproofing of concrete walls

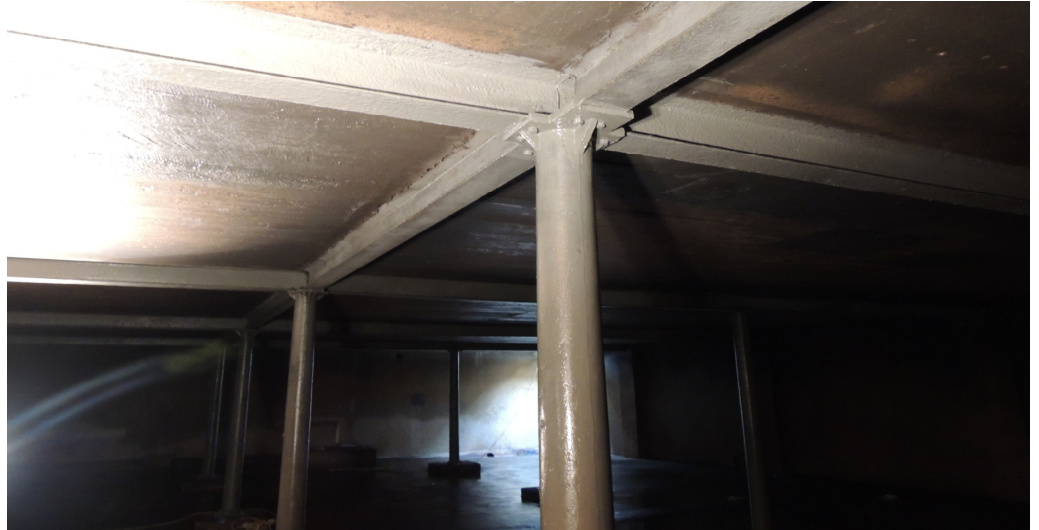
This service reservoir in Kent is over 100 years of age and consists of mass concrete walls with steel columns supporting the concrete roof. The steel columns required a protective coating to prevent corrosion and the walls required re-levelling to a smooth profile.
