Service Reservoir Roof, Sussex

Waterproofing of vaulted reinforced concrete roof

Our reference in Sussex (United Kingdom): Coombe Down Reservoir Roof

Repair of vaulted reinforced concrete roof

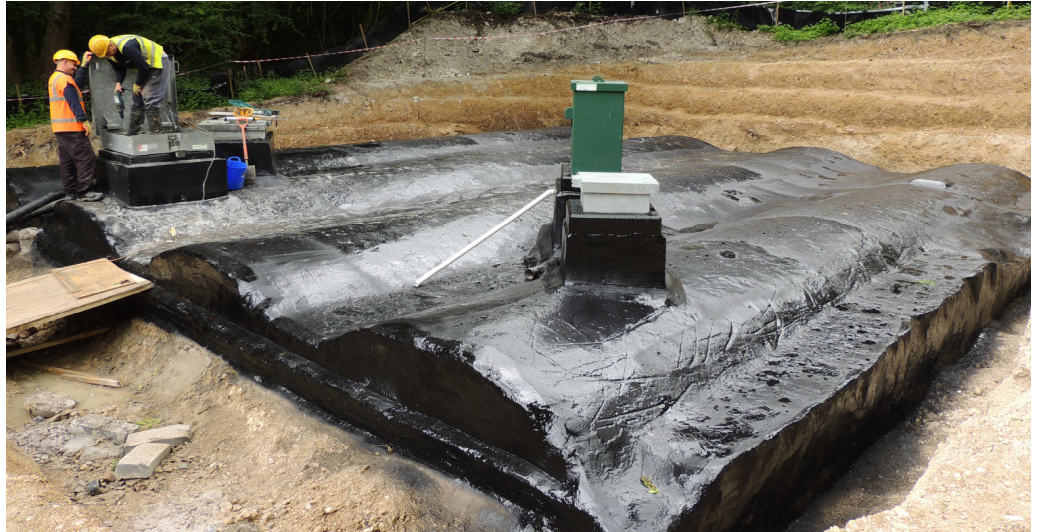
This service reservoir in Sussex is a brick construction, with a vaulted reinforced concrete roof.

The surface of the vaulted roof had many uneven connections to the brick structure and it was imperative that a seamless film build was achieved at these junctions
