Service Reservoir, Warwick

Waterproofing of joints and concrete protection

Our reference in Warwick (United Kingdom): Service Reservoir

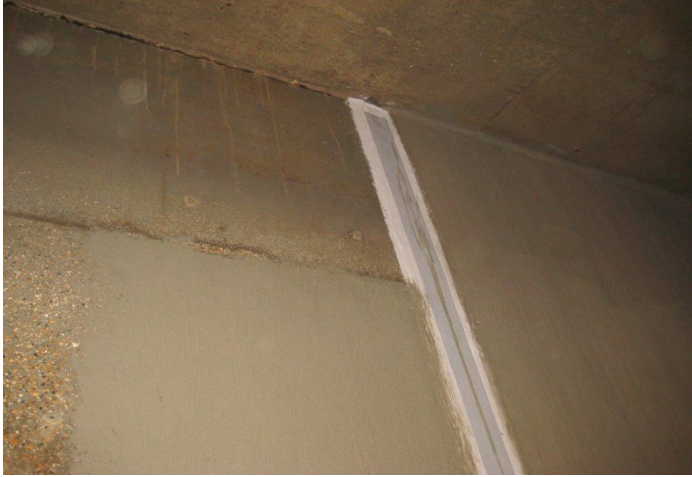
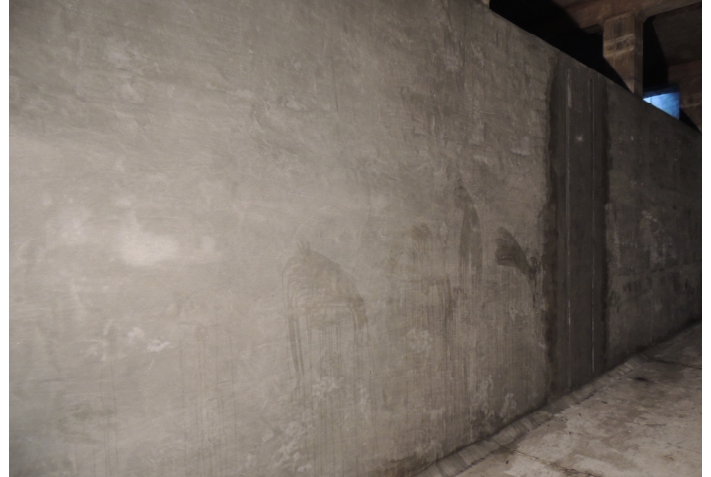
This underground service reservoir lies in the heart of the Warwickshire countryside. The concrete structure required maintenance to the joints and re-levelling of the internal concrete surface.

The concrete surface was treated with high pressure water to remove all contaminants. MasterSeal 930 bandage was applied onto MasterSeal 933 moisture tolerant adhesive to seal the vertical and horizontal joints. MasterSeal 586 was applied in one layer of 3mm to re-profile the concrete walls.
