Wastewater Manhole Chamber

Norwich

# Wastewater Manhole Chamber, Norwich

Waterproofing and concrete protection of chamber walls

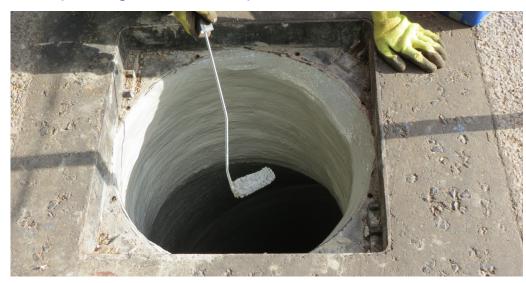
Our reference in Norwich (United Kingdom): Waste Water Manhole Chamber

The wastewater manhole chamber had shown signs of biogenic sulphuric acid corrosion which had eroded the concrete lining. The structure required the concrete to be relevelled and protected with a coating resistant to this form of attack from Anaerobic bacteria.
