Project:
Refurbishment of concrete tanks

Water Treatment Works, Northern Ireland

Refurbishment of concrete tanks

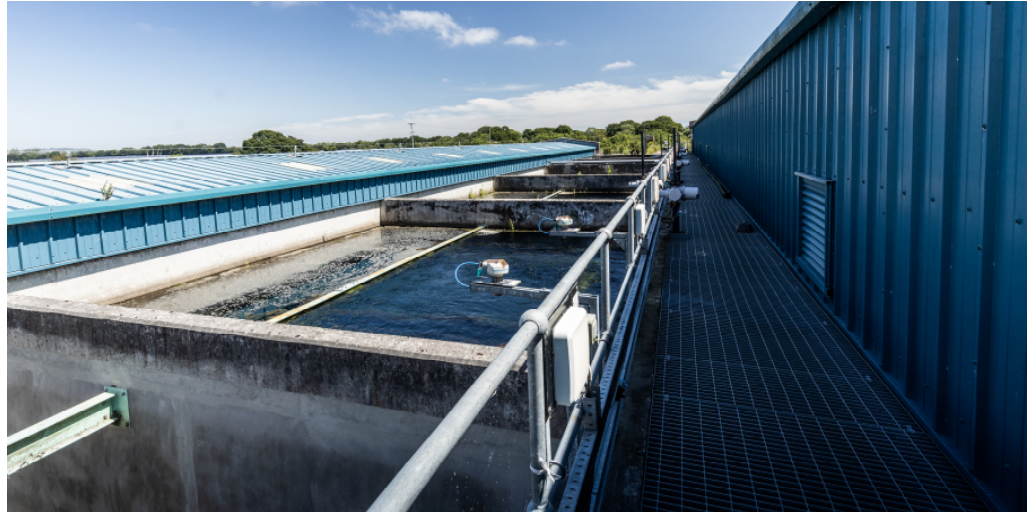
Conservations Solutions required a proposal for restoring the concrete tanks, which had corroded significantly throughout the operational life of the asset.

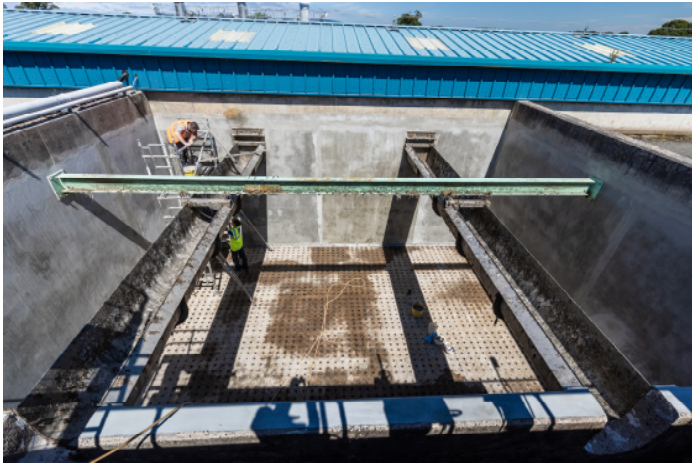
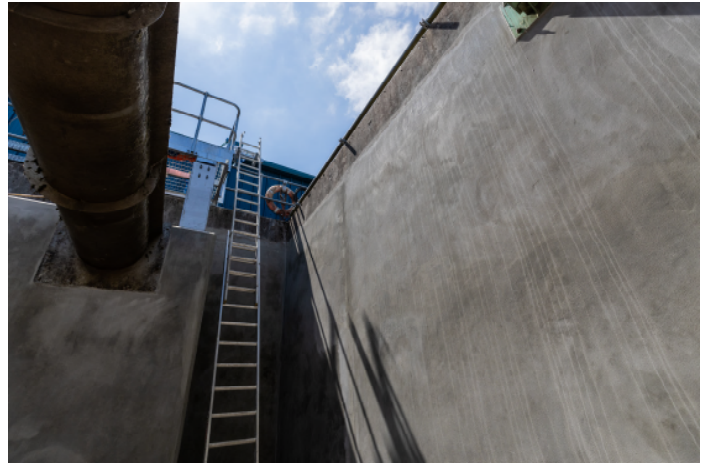
The concrete surface was treated with high pressure water to remove all contaminants. The concrete surface was repaired using MasterEmaco S 420 incorporating MasterSeal 600 polymer emulsion .

MasterSeal 586 incorporating MasterSeal 600 polymer emulsion was applied to reprofile and protect the concrete surface.
