MasterSeal 938

Waterproofing repair tape for MasterSeal application

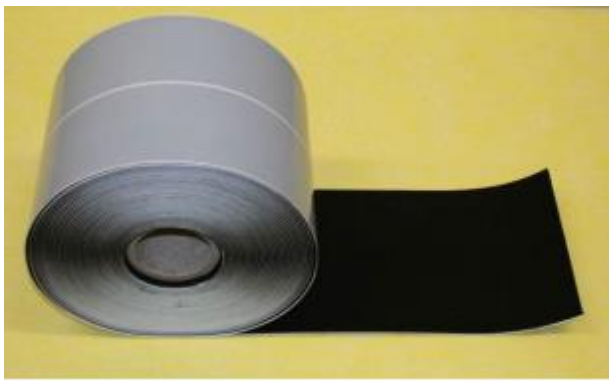
MasterSeal 938 is a waterproofing repair tape with butyl rubber coating. The tape consists of high flexible polyolefin membrane and a designed non-woven fleece with butyl rubber coating tape with release liner and overlaps for easy removal.

In **MasterSeal 754** pre-applied membrane applications, **MasterSeal 938** is placed to the edges, end points and damaged areas. Protection foil is removed from the accessory. **MasterSeal 754** is combined with self-adhesive surface of **MasterSeal 938**.
