Loaysa water tank

## LOAYSA Water Tank

### Waterproofing with MasterSeal 6100 FX and joint sealing

Our reference project in Granada (Spain): Loaysa Water Tank

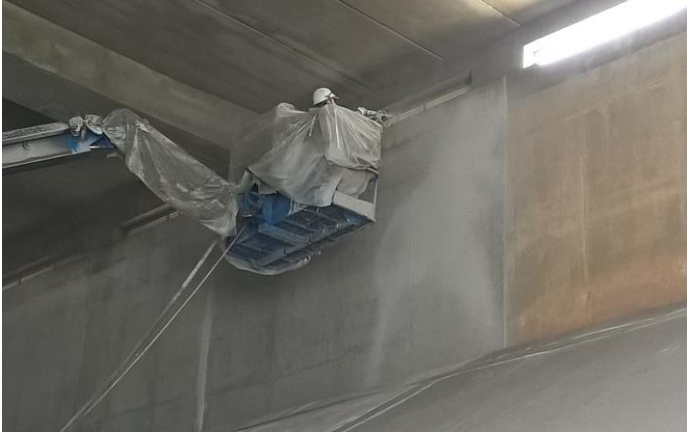
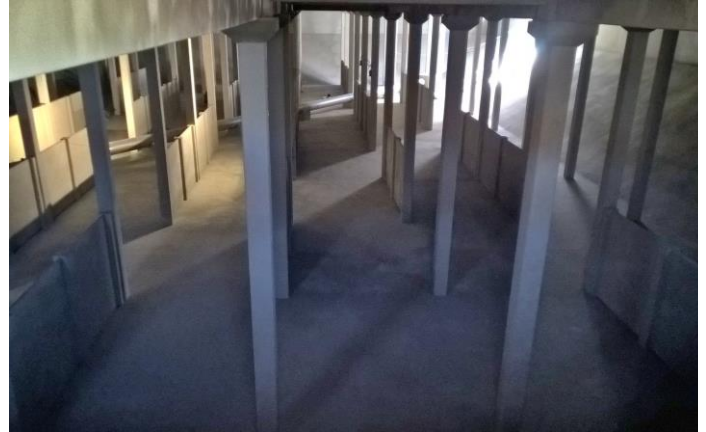
Our reference project in Granada (Spain): Loaysa Water Tank

- Surface preparation and smoothing with MasterSeal 531 rigid waterproofing slurry.
- Structural repair, where needed, using MasterEmaco S 5400 thixotropic structural repair mortar.
- Waterproofing and protection of soffit with MasterSeal 531.
- Sealing of movement joints exposed to water pressure with MasterSeal 930 elastic tape, fixed with MasterSeal 933 epoxy adhesive.
- Sealing of joints exposed to low water pressure and/or little movement with MasterSeal NP 474 single-component polyurethane mastic.
- Complete waterproofing of slab and walls with MasterSeal 6100 FX single-component elastic membrane.

- Total area waterproofed: approx. 12.500 m<sup>2</sup>
- MasterSeal 6100 FX applied with a thickness of 2 mm thickness and 1.9 kg of product per square metre
- 1.5 km of joints treated with MasterSeal 930/933 system.
- The use of MasterSeal 6100 FX instead of other traditional cementitious two-component waterproofing membranes saved in this job approx. 18 tons of waterproofing material.
